Building Audit Report for Boyton Village Hall

undertaken by Suffolk ACRE on 23rd January 2013.

Overview of the Building

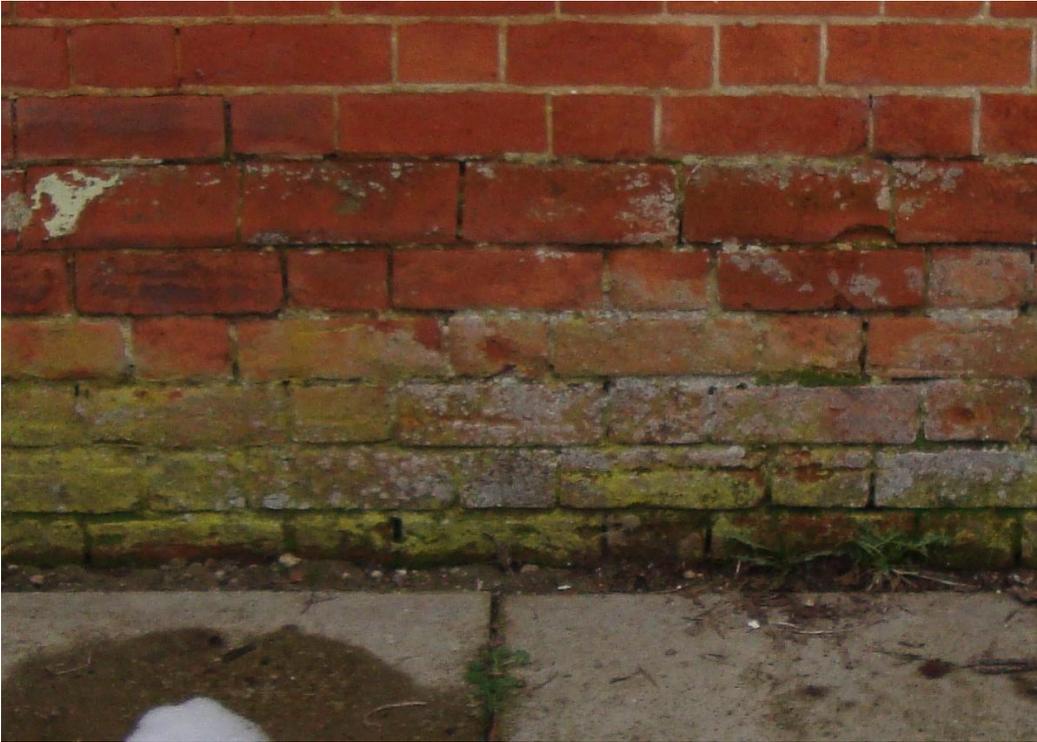
- The lower brickwork shows signs of algae / fungal infection. There was no evidence of a damp proof course. This should be monitored and action taken if it continues to be a problem. (fig1)
- There are damaged brick to the exterior corner of the porch which need repairing. (fig2)
- A gutter end was missing at the east corner.
- Very narrow UPVC external door into Kitchen with raised threshold.

Fig 1: Decay and damp to front wall

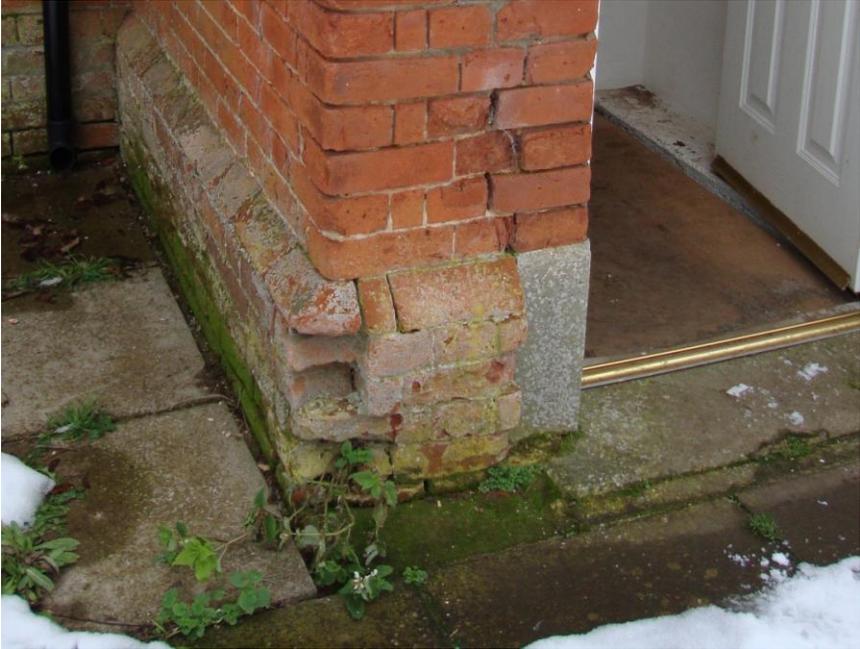
Fig 2: Damaged brickwork

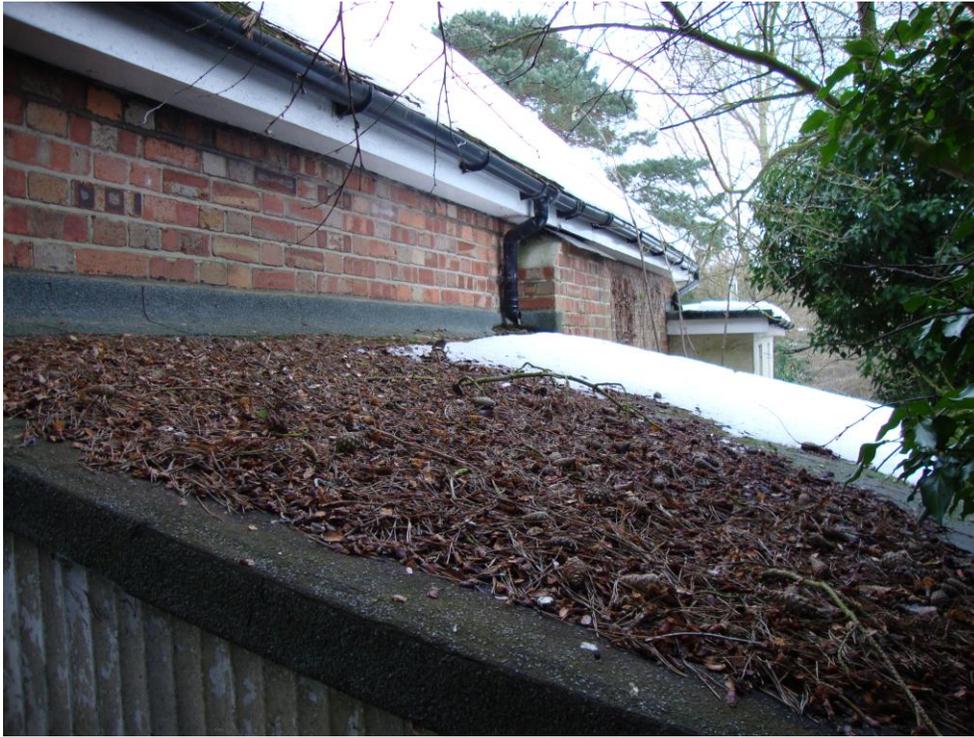
- Chimney stack has been removed.
- Lean-to shed at back is made of cement board or similar.
- Build up of vegetation / pine needles on roof of lean-to likely to cause a leak in the roof as it rots. (fig3)
- Ground level against building is raised because of vegetation / pine needles etc. This needs clearing to prevent future damp problems.

Fig 3: Roof of lean-to

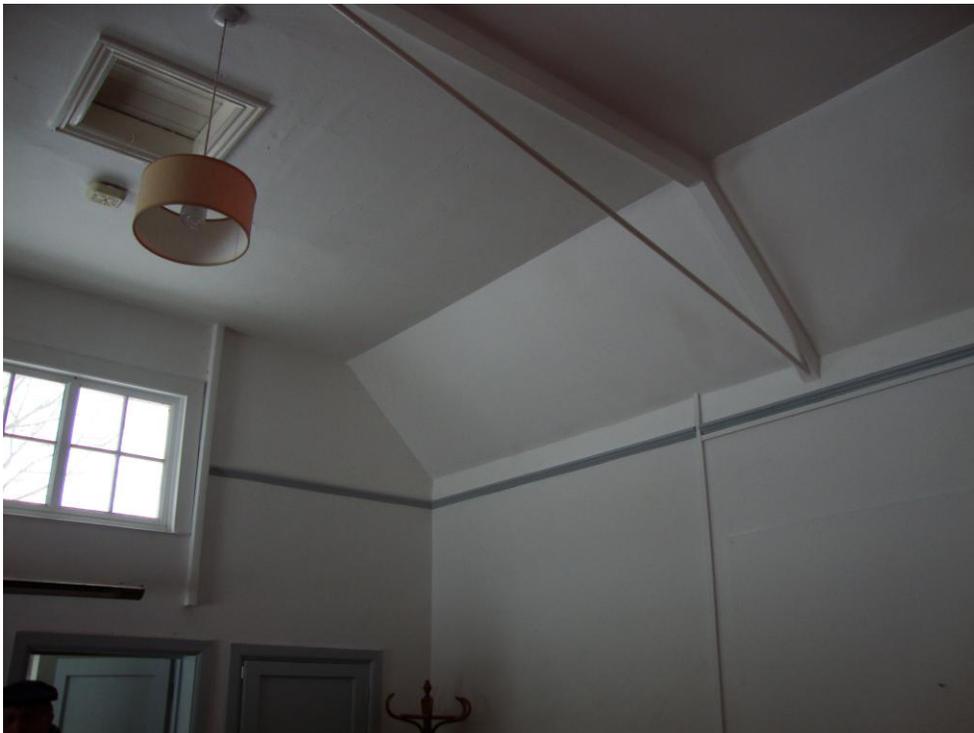
- A large room with open vaulted ceiling featuring exposed steel tie rods. There is a small loft space above, accessed by two small hatches (Fig4). This was not inspected but it is expected that the loft is under insulated, if at all. Creating a larger hatch and fully insulating the space is highly recommended.

- Smoke alarms mounted on the ceiling are out of reach for regular testing and servicing (Fig4). It was suggested that they may be out of batteries. These should be changed to ones which can be tested by a torch beam. Ideally they should be mains powered using the lighting circuit so that the batteries never need replacing.

Fig 4: Ceiling of hall showing tie beam, loft access and smoke alarm

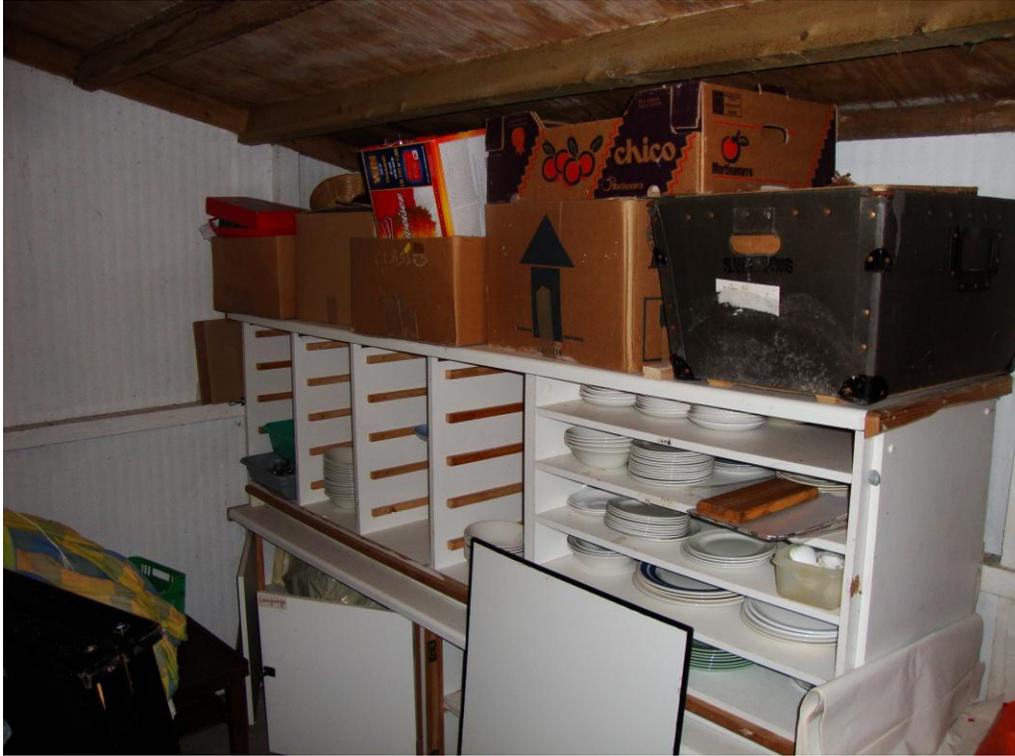
- Used to be a coal hole, now used for storage of crockery & cutlery. These need to be washed before use because the storage is not fit for purpose (Fig5).
- Unlined construction (exposed timberwork) and concrete floor.

Fig 5 : Crockery storage in lean-to

- The kitchen needs a complete refit as it is not fit for purpose and contains a number of hazards. There is a spurious internal wall which serves no obvious purpose other than to restrict the layout of the room. All of the fittings and appliances should be replaced (sink, cooker etc) with a more practical and safe layout. Several user groups have said that the kitchen is causing them problems because it is unfit. More storage space is required so that items do not have to be kept in the lean-to.

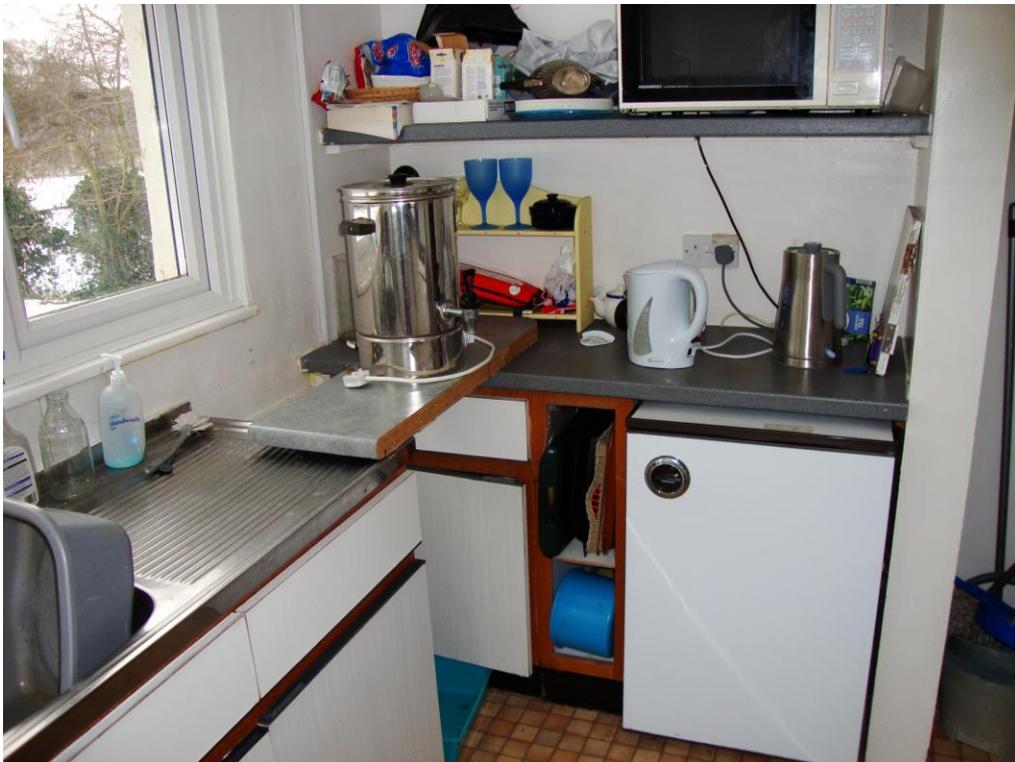
- Layout has suffered due to being cobbled together out of different pieces of furniture. Tea urn is balanced a bridge of worktop over a void which is a serious injury hazard (Fig6).
- There is insufficient storage.
- Cracked tiled splashback behind sink is unsanitary.
- Evidence of damp on the walls. No heater in room.
- External door (emergency door) is not fit for purpose: It has a 2 ½" lip to step and a greater drop the other side; It is not wide enough for escape; The key is kept in a break glass container on the wall – this is not correct. It should be unlocked at all times when the building is occupied. There is a crack above the door which indicates that there may be movement in the lintel.

Fig 6: Kitchen
